TECHNICAL CONDITION ASSESSMENT

North Dakota Veterans Home Lisbon, North Dakota

December 2006

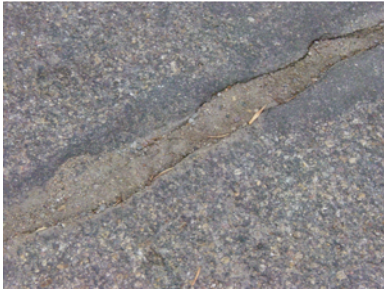
Crack in asphalt paving. Note raveling.

The asphalt is raveling in some areas (losing pavement from the top down), as well as showing slight signs of frost heave and both slight longitudinal and transverse cracking probably caused by substrate settlement and movement.

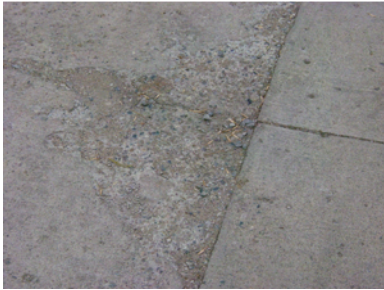
Spalling concrete paving. Note pop-outs.

The resident parking lot is paved with concrete. The surface has many pop-outs, and is both scaling and spalling in numerous places. There are also numerous cracks, ranging from hairline to significant.

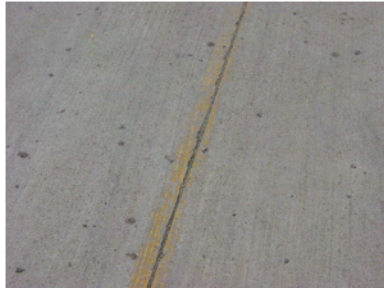
Parking striping fading away.

In all the parking areas the striping is either worn off or fading away.

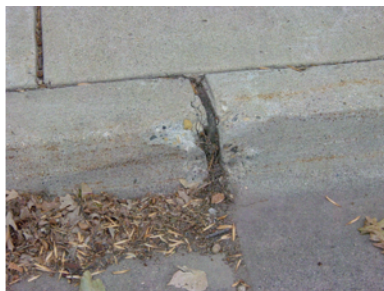
Damaged concrete curb.

Concrete curbs exhibit some minor damage, most likely caused by snow removal equipment.

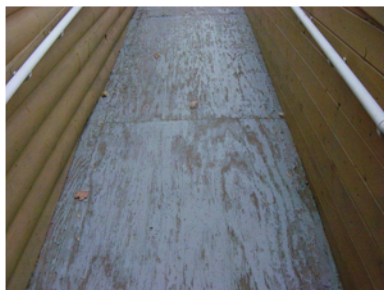
Finish on ramp at Gazebo deteriorating.

The finish on the plywood ramp from the Gazebo deck is deteriorating. Staff indicated that the Health Dept. required the area beneath the ramp to be completely filled so that sprinklers would not have to be installed. Because of this there is little ventilation, allowing moisture to build up.

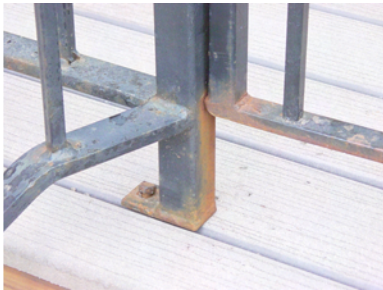
There is a metal railing at the main entrance. The paint is deteriorating and the metal is rusting in many places.

Rust on metal railing.

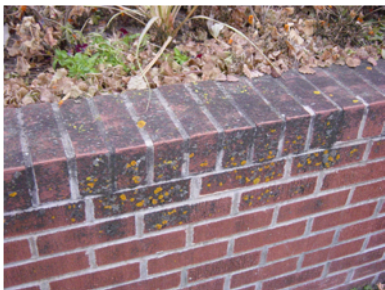
There is a lighted monument/planter sign at the entrance to the site. The sign itself is in satisfactory condition, however the joints in the brick base are deteriorating due to water in the planter, and lichens are growing on the brick on the north side.

Lichens growing on brick sign base.

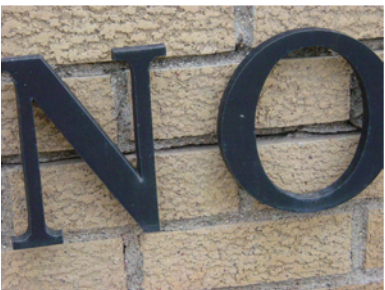
There is another monument/planter sign just east of the main entrance. The metal letters are in satisfactory condition, but the mortar joints in the brick base are deteriorating due to water in the planter.

Deteriorating mortar joints.

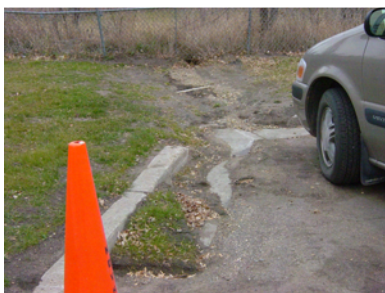
Erosion at staff parking lot.

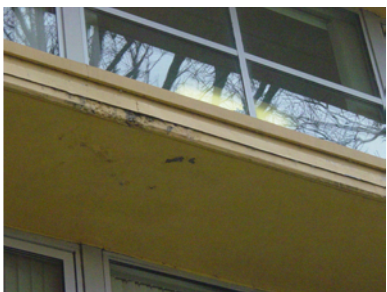
Concrete sun shade spalling.

The original portion of the building has cast-in-place concrete bearing walls around the perimeter, and structural clay tile bearing walls on each side of the center corridor. No problems were observed. At the north and south ends of the original portion there are cast-in-place concrete beams with painted, cantilevered concrete sun shades above the windows. The paint on the sun shades is deteriorating and the concrete is spalling.

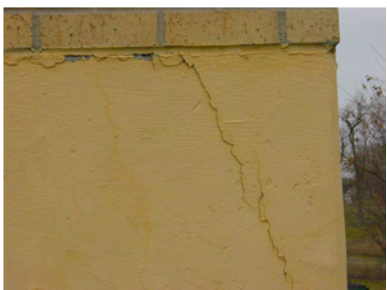
Crack in concrete bearing wall, SE corner of south wing, 1990 addition.

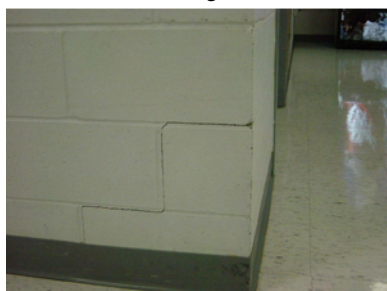
Crack in concrete masonry bearing wall, first floor, 1990 episode.

The first floor of the 1990 episode has cast-in-place concrete bearing walls at new perimeter walls. On the second floor the new perimeter walls are concrete masonry units. This episode also utilizes the bearing walls of the original portion. One small crack was observed at the SE corner of the south wing, 1990 episode. There are a couple of small cracks in the concrete masonry bearing walls in the corridor on the first floor.

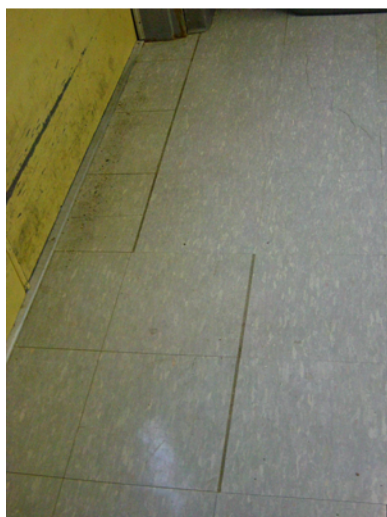
Gaps in joints between tile in Receiving Room, 1990 addition.

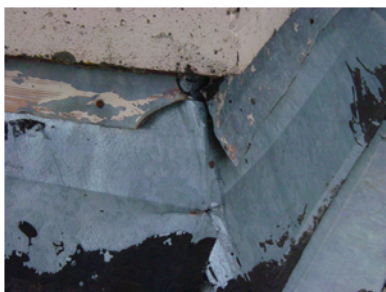
Badly bent metal flashing.

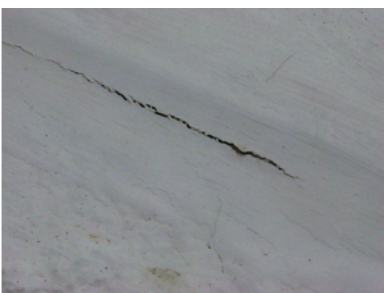
Crack in surface of roof repair.

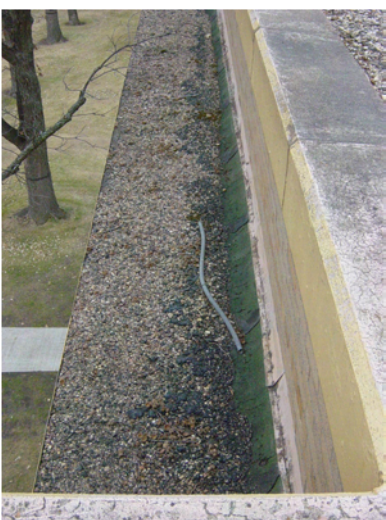
Built-up roof on sun shade.

The concrete sun-shades on the west side of the building also have a built-up asphalt roof system. The edge of the concrete shows signs of spalling in several places, indicating water infiltration beneath the roof membrane. Also, the aggregate is missing from significant areas, exposing the roof system to UV rays. In addition, the mineral-surfaced cap flashing is cracking in many places.

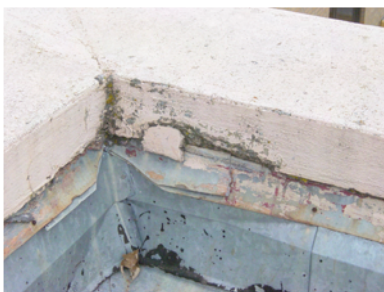
Deteriorating concrete coping.

The parapet around the entire building is capped with a precast concrete coping. The coping on the original portion of the building is spalling and pitting. In addition head joints have deteriorated or are deteriorating and should be replaced. Directly above the main entrance, one section of coping has shifted such that it sticks out past the wall 1" - 2".

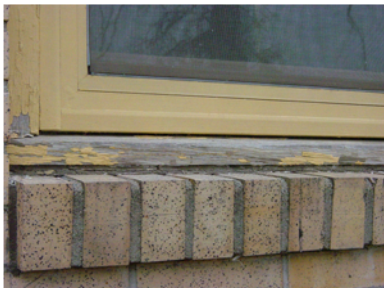
Deterioration of window sill and caulking.

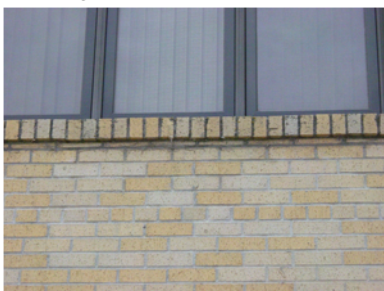
Mortar joints at sill deteriorating.

The brick is in satisfactory condition, however mortar joints are deteriorating at some window sills, and behind downspouts on the north side of the original portion and the 1990 infill portion. In addition there are several small holes in the mortar on the north side of the east wing, 1990 episode. The lintel supporting the brick above the window on the west end of the 1990 Activity Room does not extend the full width of the opening.

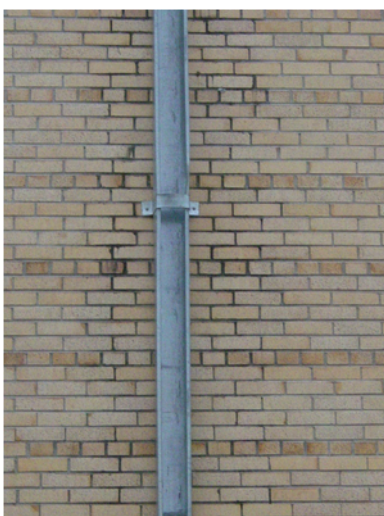
Mortar joints behind downspout deteriorating.

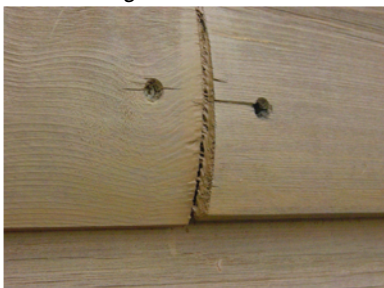
Log siding shrinking and splitting.

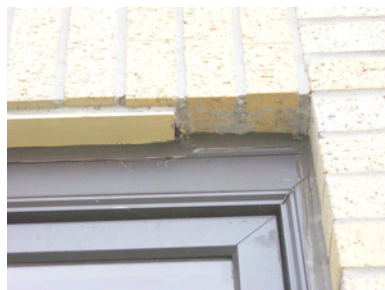
Lintel does not extend full width of opening.

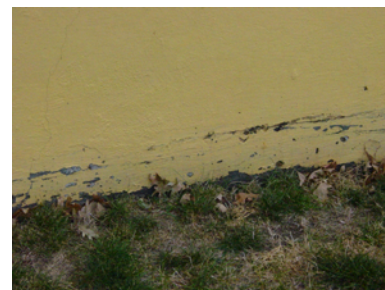
Paint damaged by lawn care equipment.

The paint is spalling off of the concrete in several places. In addition the paint is being scraped off the walls at the bottom by lawn care equipment. One small area adjacent to the main entrance was not re-painted when a sign was removed. On the west side of the east wing, 1990 addition, the painted wall is badly soiled from an exhaust vent.

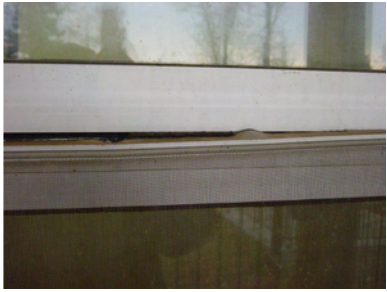
Failure of caulking at aluminum window adjacent to entrance.

adjacent to the main entrance. These aluminum windows are not original to the building as the plans indicate steel sash windows. The caulking around the perimeter of the aluminum windows adjacent to the entry has failed. Only the windows in the 1980 episode provide satisfactory thermal insulation.

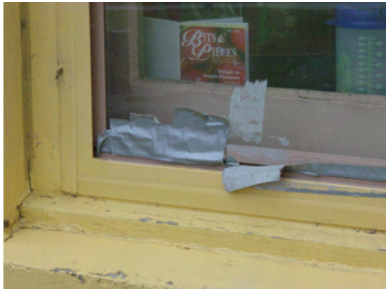
Duct tape used to repair window.

The interior finish of the wood windows is in satisfactory condition for the most part, however the painted finish on the exterior has deteriorated, especially at sills, allowing the wood to check and split. Duct tape was used to make repairs to a window on the west side of the Resident Dining Room. One pane of glass in the Resident Dining Room is broken. Windows on the Ground Floor (lowest level) are difficult to open for some residents and staff due to the height of the sash above the floor. No problems were observed with the aluminum windows at the north and south ends of the original portion.

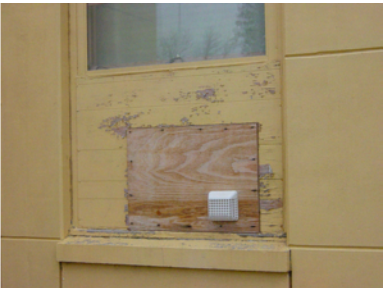
In-filled window; note paint deterioration.

Several windows have been filled in with painted wood. The paint is deteriorating in most of these cases.

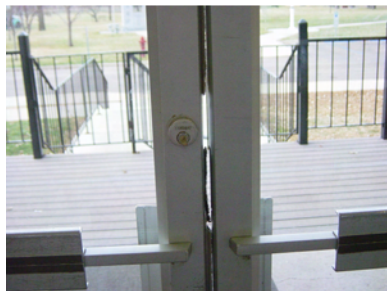
Lack of weatherstripping between door leaves.

The main entrance doors are aluminum with single glazing. The weatherstripping around and between the door leaves does not provide an adequate seal. Light is visible between the door leaves. The sidelites have single glazing in wood frames. The finish on the wood, both interior and exterior, is deteriorating. Other exterior doors in the original portion of the building are painted hollow metal in painted steel frames, with wired glass and old hardware and weatherstripping.

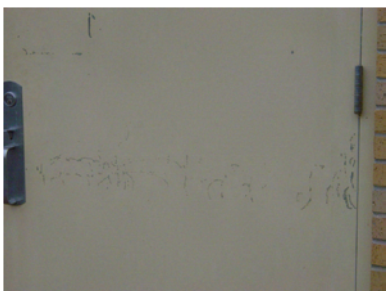
Paint on door scratched.

Exterior doors at the 1990 episode are painted hollow metal in painted steel frames. The paint on the door from the SE corner of the Activity Room is scratched and deteriorating. At the pair of doors on the north side of the Mechanical Room, north of

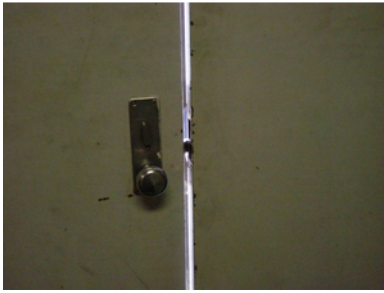
Lack of weatherstripping between door leafs.

the 1980 addition, there is no weatherstripping between the doors, and the bottom of the doors is rusted.

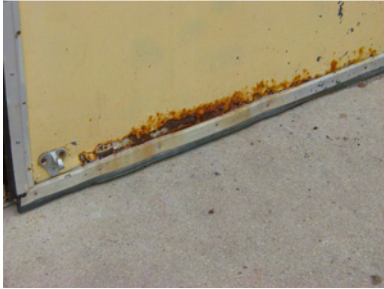
Door to Mechanical Room rusted.

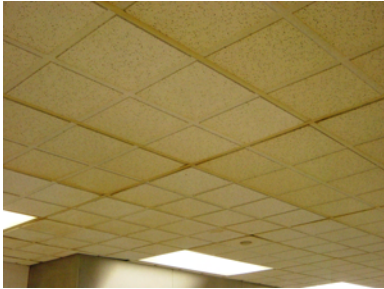
Stained ceiling above serving line.

There are many places throughout the facility where the ceiling tiles have or are beginning to warp, as evidenced by corners raising up from the grid, or sag. The ceiling, including the suspension system, above the serving line in the Resident Dining Room and in the Smoking Lounges is badly stained. Tiles adjacent to a couple of supply air registers are dirty. Tiles and suspension systems in shower areas in the original portion of the building do not appear to be moisture-resistant type. There are water stains on only a few tiles. And tiles in several areas are scratched and otherwise slightly damaged. Tiles in several places have been cut or otherwise modified to accommodate new wiring etc.

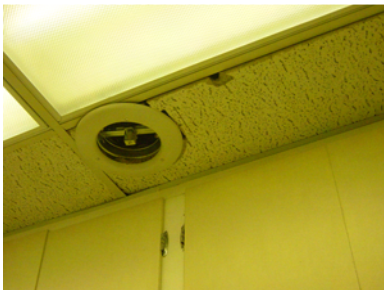
Damaged ceiling tile.

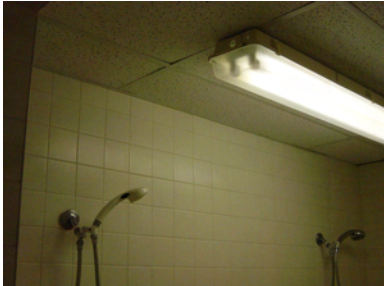
Non-water-resistant tile in shower.

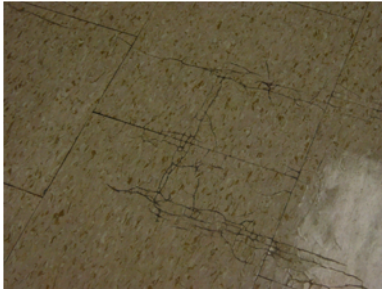
The ground floor (lowest level) in the original portion of the building is a concrete slab on metal deck supported by steel joists. There are cracks in the vinyl tile behind the serving line in the Resident Dining Room that could indicate some minor deflection. No significant problems were observed. The ground floor in the remainder of the facility is a concrete slab-on-grade. There are significant floor tile cracks and gaps in joints adjacent to the exterior doors at the Receiving Room. Staff reported that a portion of the floor slab was cut out and replaced because it had settled. The existing cracks and gaps have occurred since that replacement. Minor cracks in the vinyl tile adjacent to the elevator in the 1980 episode could be indicative of slab settlement.

Cracked tile at serving line.

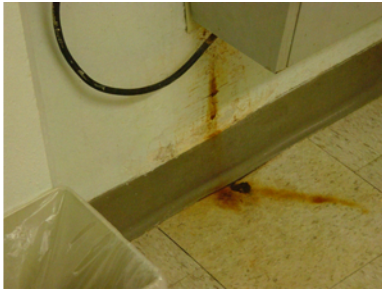
Water stain under electric water cooler.

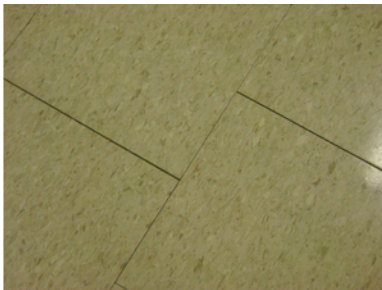
Excessive joints in corridor.

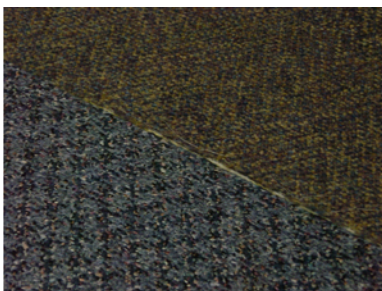
Seam between corridor and resident room carpet.

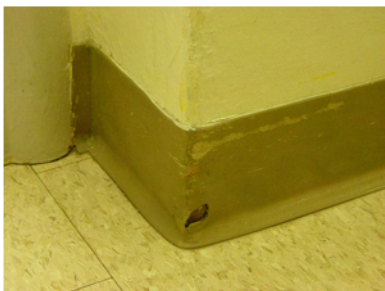
Damaged wall base in original portion of building.

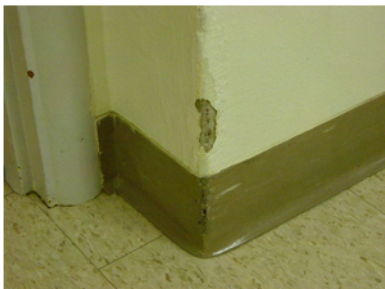
Wall corner damage.

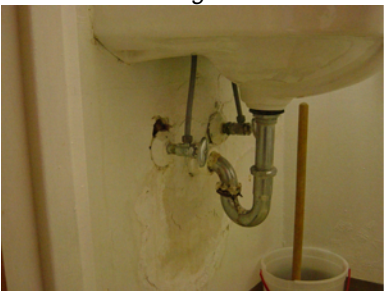
Water damage beneath lavatory.

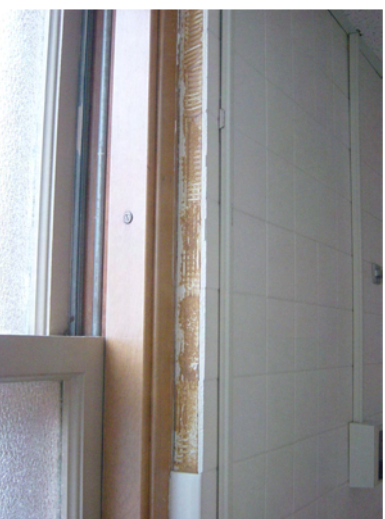
Ceramic tile missing at window jamb.

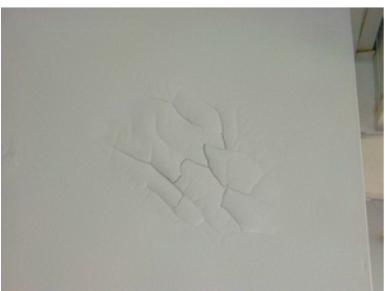
Paint peeling from wall in Library.

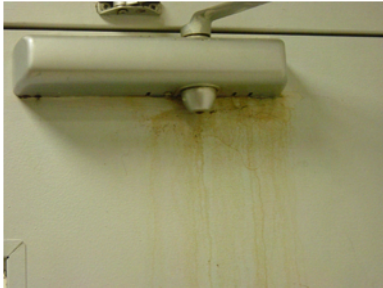
Closer leaked fluid staining door.

which give an “institutional” appearance. Some closers shut doors too hard and should be adjusted or replaced.

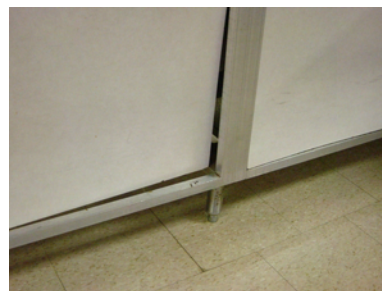
Panel loose at serving line.

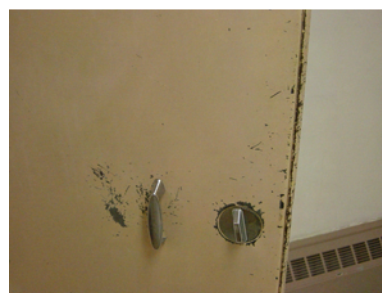
Deteriorating finish on toilet partition.

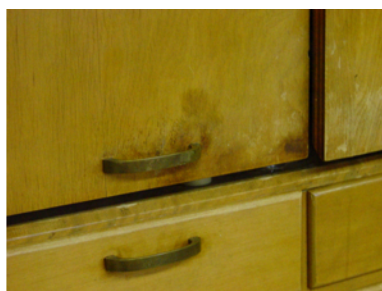
Deteriorating cabinets in original portion of building.

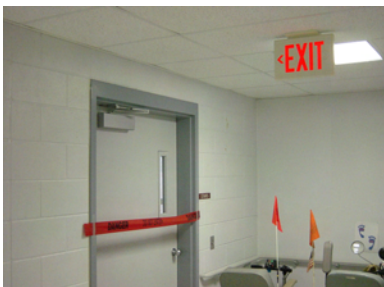
Exit door blocked off. Note motorized wheelchairs adjacent to exit.

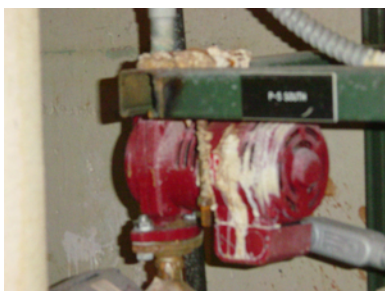
Efflorescence on pump.

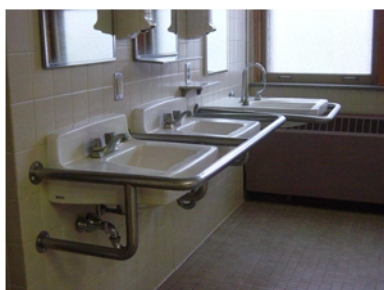
Plumbing fixtures, faucets and trim in the original portion of the facility have exceeded their useful life and should be replaced. Those fixtures, as well as those in the 1980 addition do not conform to current, recommended water-usage limits. Fixtures in the 1990 episode are in satisfactory condition. See also "Codes - Handicapped Accessibility: Toilet Rooms".

Lavatory in original portion of building. Note faucets.

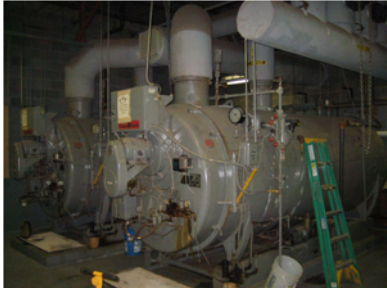
Boilers #1 and #2.

Two of the Power House boilers (#1 and #2) are 1956 Cleaver Brooks fuel oil boilers used for additional heating capacity during cold weather and as standby units, while the third (#3) is a CAM'S Industry electric boiler, installed in 1981. This boiler operates continually and is taken off-line only for maintenance and repair. The fuel oil boilers require a good deal of maintenance to remove by-products of combustion. In addition, while all three boilers appear to be in relatively good operating condition, the fuel oil boilers have exceeded their expected useful life-span, and the electric boiler is approaching its expected useful life-span.

While these boilers are in fairly good condition for their age, and repairs to all the boilers can continue to be made to keep them operational, the repairs will become more difficult and more expensive as time goes by. Metal parts begin to exhibit fatigue due to frequent heating and cooling. This fatigue is evidenced by cracks. In addition, replacement parts will become more difficult to obtain.

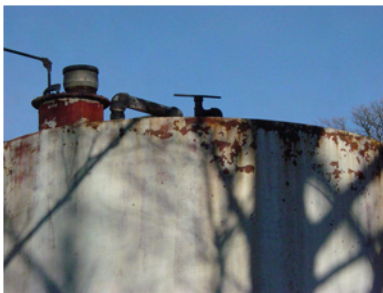
Deteriorating finish on fuel storage tanks.

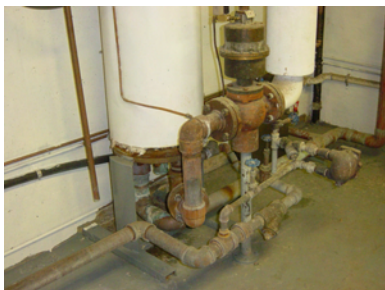
Water heater; note lack of insulation on piping.

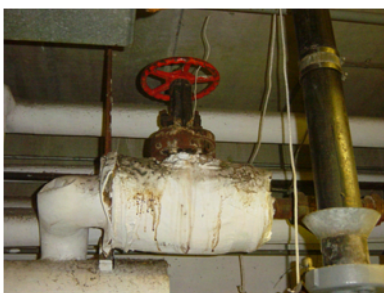
Deteriorating insulation on piping.

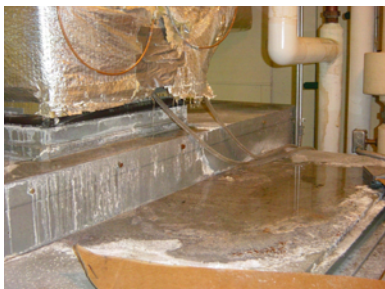
Water on AHU #6 from leaking humidifier.

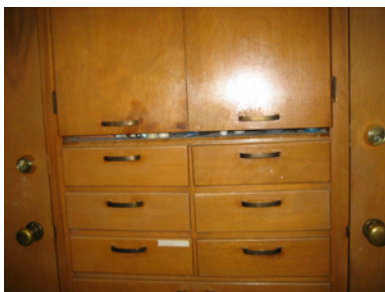
Exhaust air is drawn through gap between upper and lower portions of storage unit.

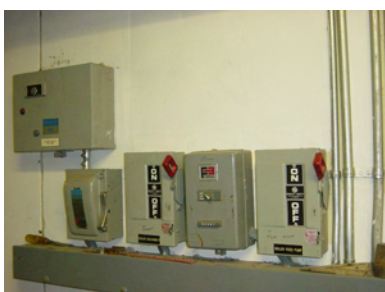
Older disconnects at boiler #4.

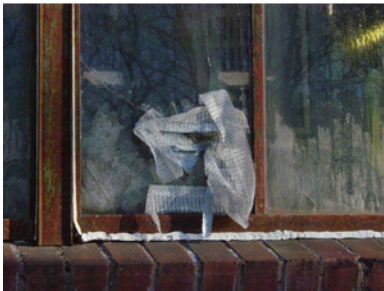
Rusted steel window with broken glass.

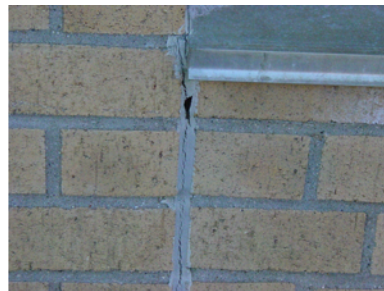
Deterioration of expansion joint.

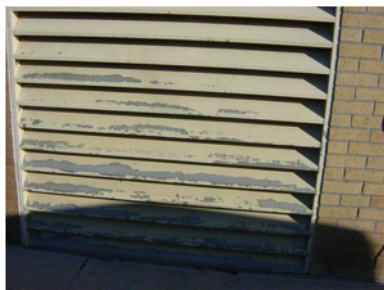
Deteriorating finish on louver.

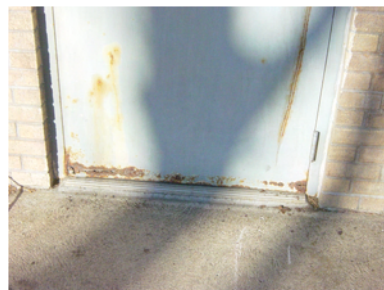
Deteriorating finish and rusting door.

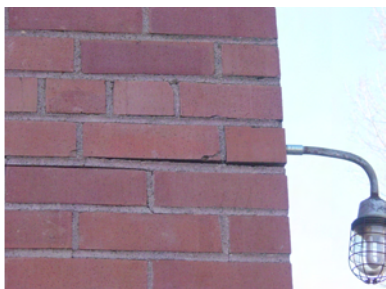
There are significant cracks in the brick veneer, and the north wall is severely bowed outwards. The mortar joints are also deteriorating.

Cracks in brick veneer and deteriorating mortar joints.

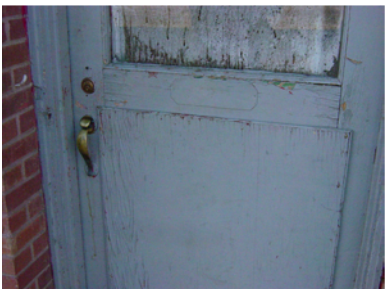
Deteriorating finish and wood.
